Permafrost and landslide activity: Case studies from southwestern Yukon Territory

Yukon Geological Survey

Huscroft, C.A., Lipovsky, P. and Bond, J.D., 2004. Permafrost and landslide activity: Case studies from southwestern Yukon Territory. *In: Yukon Exploration and Geology 2003*, D.S. Emond and L.L. Lewis (eds.), Yukon Geological Survey, p. 107-119.

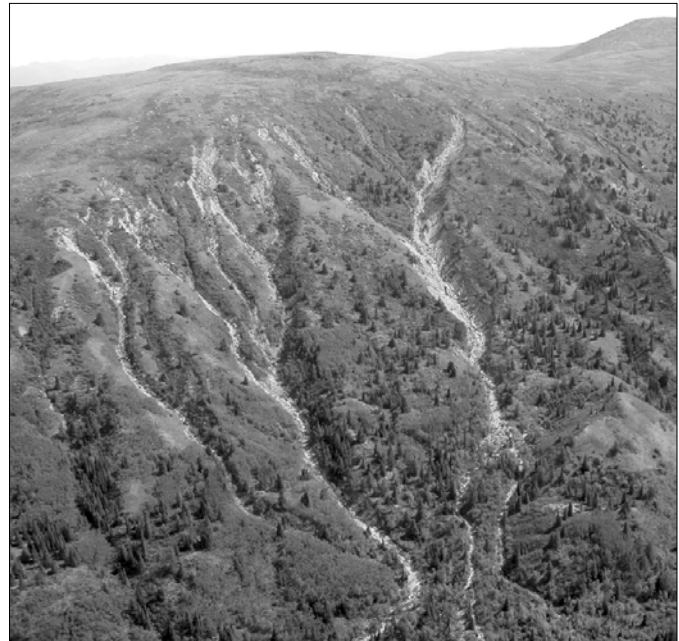
Figure 2. Oblique aerial view of Mount Sumanik debris flow channels. View is to the northeast.

A series of ten debris flow channels in a basin draining Mount Sumanik demonstrate how the presence of a shallow frozen substrate may predispose an alpine slope to debris flow activity (Figure 2). Mount Sumanik is located 15 km west of Whitehorse. The basin containing the landslides drains westward. Instabilities are confined to the southwest facing slopes of the drainage basin, and occur on the apex of convex alpine slopes in silty till deposits and colluvium. The failures were initiated on moderately steep slopes (24° - 29°) and traveled down the more moderate mountain side (15° - 25°) scouring gullies up to 47 m wide and 13 m deep, commonly to bedrock (Figure 3). Continued retrogression is evident in the headwalls and on some of the sidewalls. The flows

traveled up to 680 m to valley bottom and produced fans containing boulders up to 2 m in diameter. Individual deposits are less than 2 m thick. The source material was a colluviated till composed of subrounded granules to boulders in a sandy silt matrix.

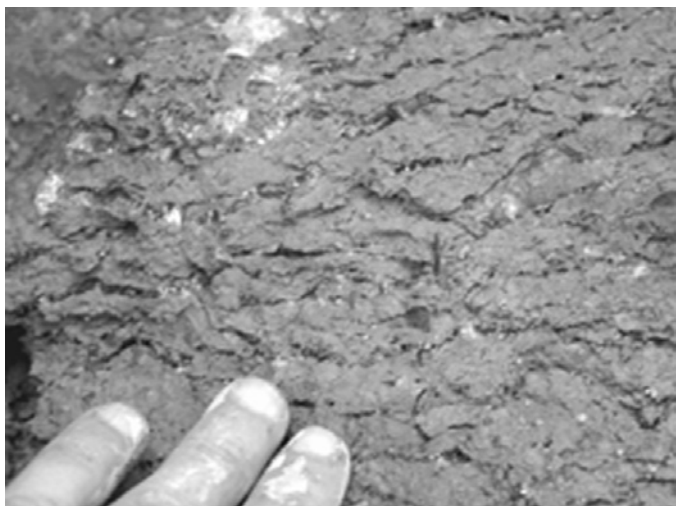
Figure 5. Photograph of frozen soil with stratified ice veins (1-3 mm thick) from Location B, the unburned forest site in Figure 4.

In order to gain insight into the depth and character of permafrost within the burned area, a trench adjacent to the headscarp of landslide 99 was excavated in late August (Location A, Fig. 4). However, permafrost was not encountered within the 1.35-m-deep trench. A second pit was dug in the unburned white spruce forest directly below the slide scars (Location B, Fig. 4). Here, permafrost was uncovered at a depth of 70 cm, beneath 25 cm of organic mat and 45 cm of unfrozen mineral soil (Fig. 5). The permafrost contained stratified segregated ice veins, 1-3 mm thick, composing 15% (by volume) of the soil.

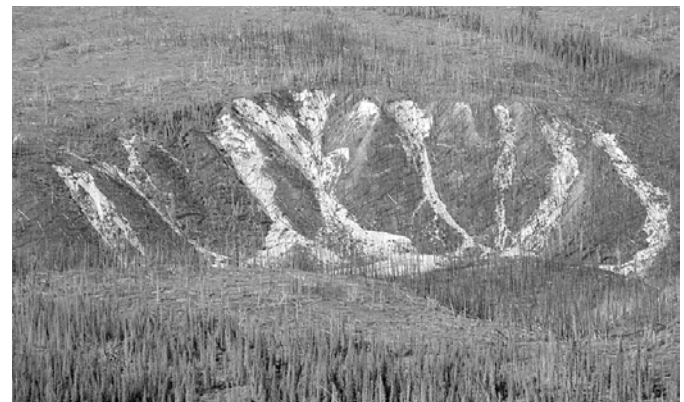
Figure 9. Oblique photograph of debris flow scars originating from scarp of terraces formed in glacial material along Marshall Creek.

The debris flows of the Marshall Creek basin can be divided into two groups based on the landform within which they originated. The majority of the landslides (36) developed on the scarp of high-level terraces composed of glacial and fluvio-glacial material (Fig. 9). In comparison, a lesser number (5) of the landslides occurred on gentle till-blanketed valley sides. Much of the valley fill was deposited as ice advanced and retreated from the Marshall Creek valley during the late Wisconsinan McConnell Glaciation. During this advance and subsequent retreat, silt-rich till blankets were deposited on valley sides and a thick fill of silt-rich till and glaciolacustrine and glaciofluvial strata was deposited in the valley bottom.

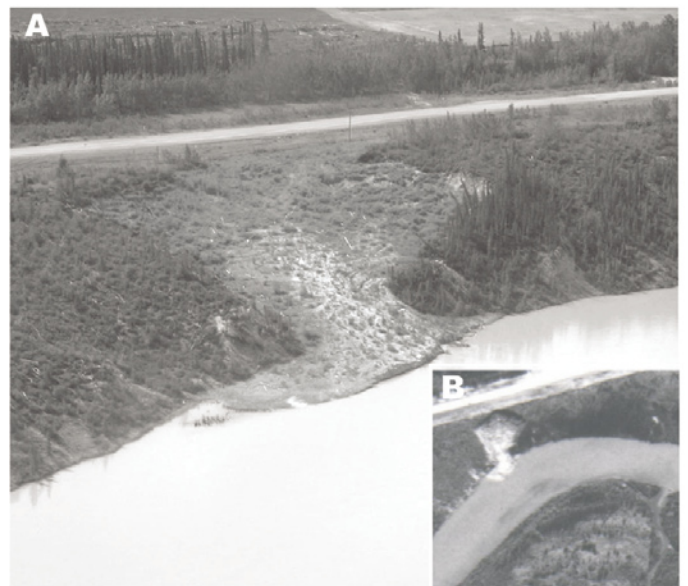
Figure 11. (a) Oblique aerial photograph taken in 2003 of Takhini River retrogressive ground ice slump. (b) Inset aerial photograph taken in 1987 of Takhini River retrogressive ground ice slump.

A retrogressive thaw slump is located adjacent to the Alaska Highway, 25 km west of Whitehorse. The failure occurred in a terrace composed of laminated silt and clay, and is representative of eight other failures that have occurred within 6 km of this location. The terrace's surface lies 11 m above the river, is locally ice-rich, and hosts numerous thermokarst lakes. The slump has an approximately 7-m-high, 107-m-wide, semi-circular headscarp. During field visits in the summer of 2003, the western portion of the headscarp was near vertical, and the remainder of the headscarp exhibited a slope of 25° with fresh terracettes extending back to the embankment of the Alaska Highway. These features indicate recent retrogressive activity. From the headscarp area, a 132 m, low angle (7°) tongue extends into Takhini River (Fig. 11). The river has eroded the fine-grained material leaving a 1.7 m stream cut at the landslide toe. The volume of the failure is on the order of 40 000 m³.

slumping had caused the terrace scarp to recede approximately 25 m. Between 1979 and 1986, further slumping had caused the headscarp to retreat an additional 112 m to near its present position. Since 1986, the headscarp has retreated several metres and decreased its slope substantially.

River erosion-related thawing of ice-rich sediment caused the failure of fine-grained lacustrine terraces along Takhini River. The morphology of the thaw slump is characteristic of bi-modal flows (McRoberts and Morgenstern, 1974). It has a semi-circular, amphitheatre-like headscarp and biangular profile. The flow has a low-angle tongue (7°) and, when active, had a steep headscarp (Fig. 11). In general, retrogressive thaw slump development is initiated when the vegetation or active layer materials are removed causing thaw of icy material. The thaw slump under investigation is on the cut bank of a migrating meander of the river; the meander is propagated by a tributary alluvial fan entering Takhini River on the opposite bank.
